Home Inspection Report

Inspected By: United Home Inspection Group LLC

Inspected On Sun, Jun 5, 2022 at 1:00 PM

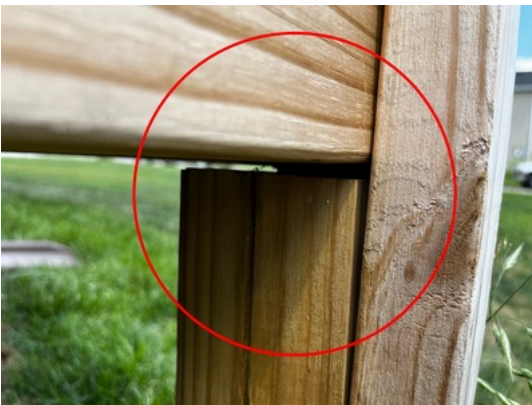
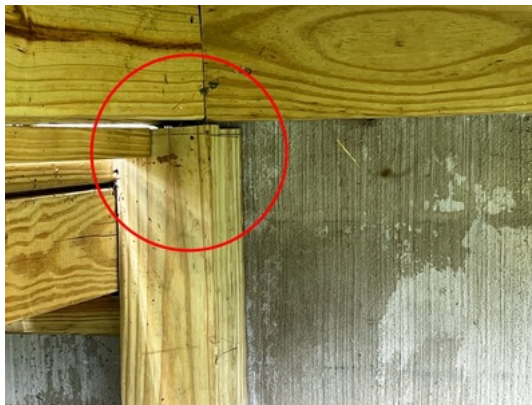
Site: Patios/Decks

Back porch Rim Joist not supported by 4 x 4 posts, being held up by hand rail posts. Showing signs of wood splitting at pressure points. Recommend repair by qualified professional.

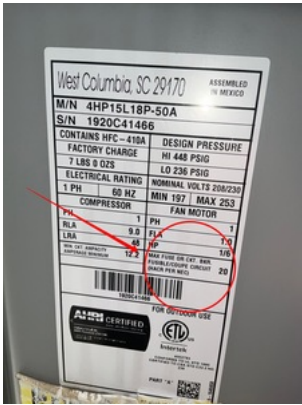
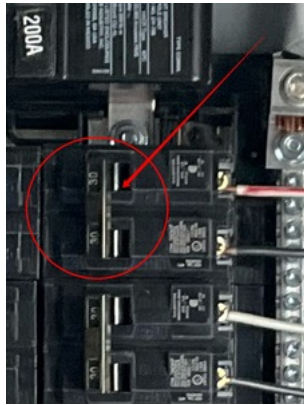
Electrical: Overcurrent Protection

Air Conditioner data tag depicts max breaker size as 20A, Electrical panel has 30A breakers installed for Air Conditioner. Recommend evaluation and repair by licensed Electrician.

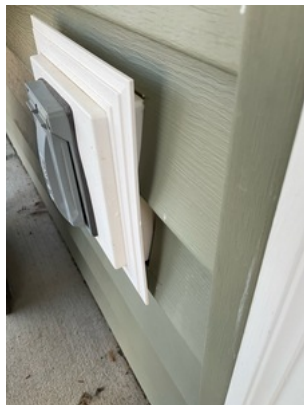
Exterior: Exterior Covering

Area where Conduit is attached to home has not been sealed. Recommend sealing holes/gaps in vinyl to prevent moisture intrusion.

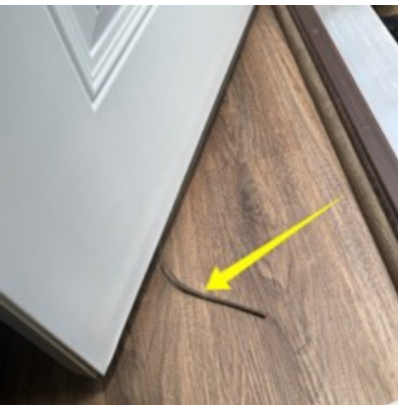
Exterior: Entry Doors

Back door lower weatherstripping torn. Recommend replacement to keep moisture and pests from entering home and to provide better insulation properties

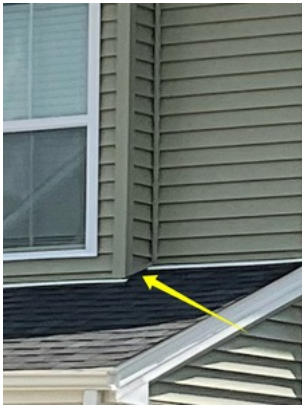
Roofing: Flashings

Area where dormer wall meets rooftop shingles needs flashing to divert water from pooling under vinyl siding edge (which should terminate 2 inches above adjoining roof. Where there is no flashing, shingles and sheathing can allow moisture intrusion over time. Recommend repair on left and right sides of dormer by a licensed roofing contractor.

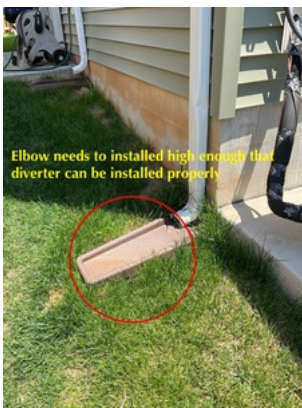
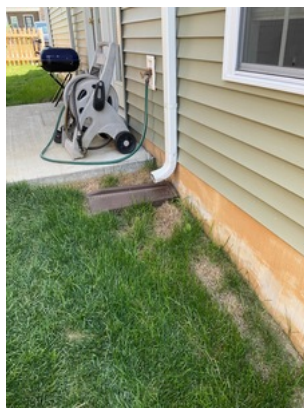
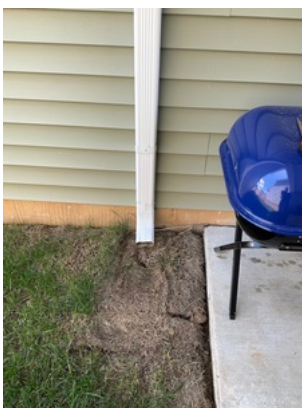
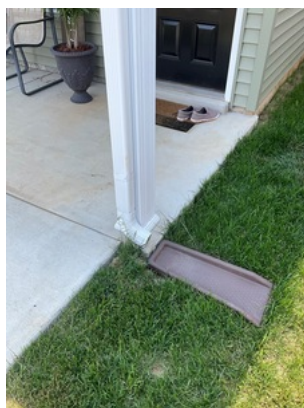
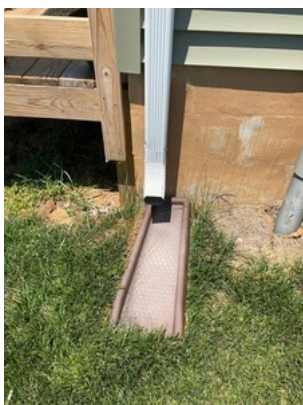
Roofing: Gutters & Downspouts

Add gutter extensions to all gutter downspouts to direct water away from home foundation to prevent weakening of the foundation.

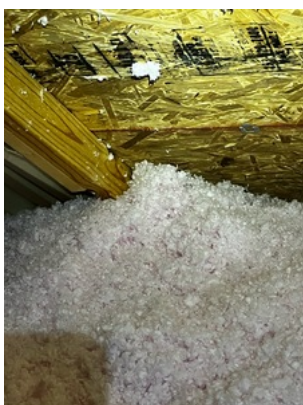
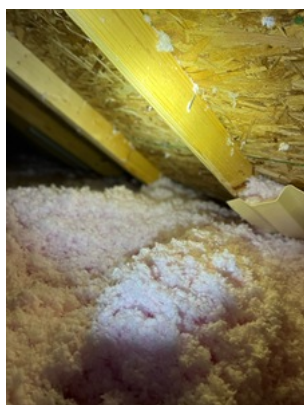
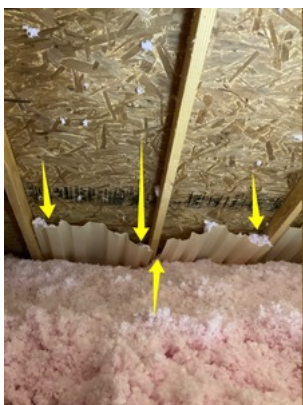
Attic: Insulation

Blown-In insulation covers Soffit vents and guards in some areas. Recommend clearing insulation from the vents/guards. At the time of inspection there were not any moisture issues noted, which can occur with blocked soffit vents. Opening soffit vents can result in a cooler roof surface and longer shingle life, even if there are no moisture problems present. Higher than expected attic temperature was noted at time of inspection.

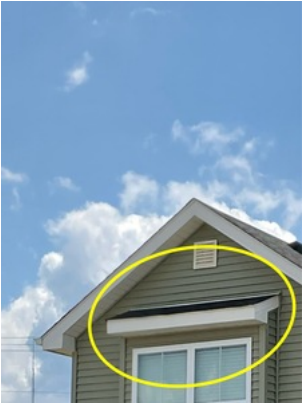
Roofing: Gutters & Downspouts

Add section of gutter with downspouts directed off the roof at this roof edge to prevent damage of shingles on roof to below this section

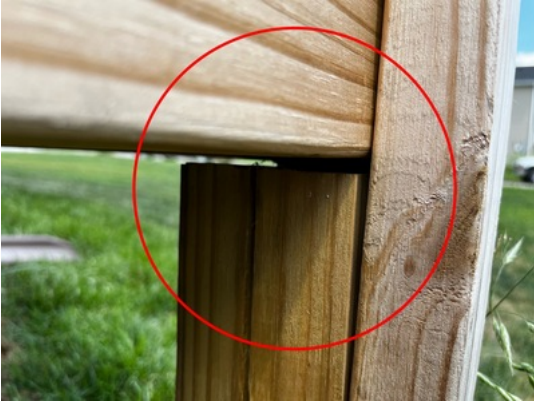
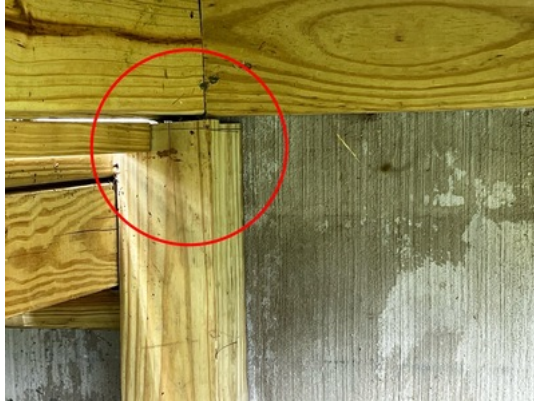
Comment 3

Back porch Rim Joist not supported by 4 x 4 posts, being held up by hand rail posts. Showing signs of wood splitting at pressure points. Recommend repair by qualified professional.

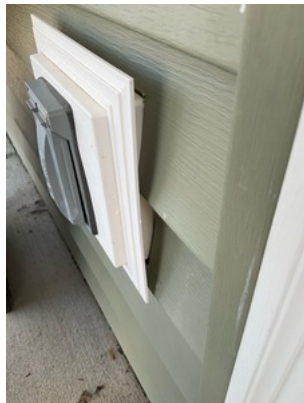
Comment 5

Area where Conduit is attached to home has not been sealed. Recommend sealing holes/gaps in vinyl to prevent moisture intrusion.

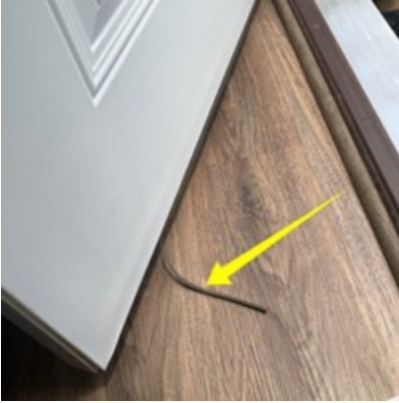
Comment 6

Back door lower weatherstripping torn. Recommend replacement to keep moisture and pests from entering home and to provide better insulation properties

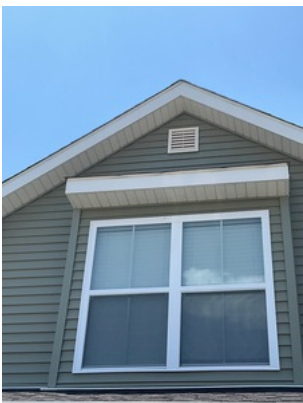
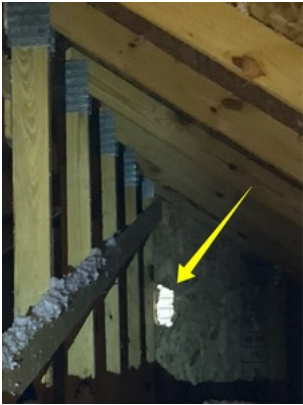
Comment 8

Gable end vent on front of home is blocked by sheathing on the attic side. Recommend qualified professional to open gable end vent to provide better attic ventilation.

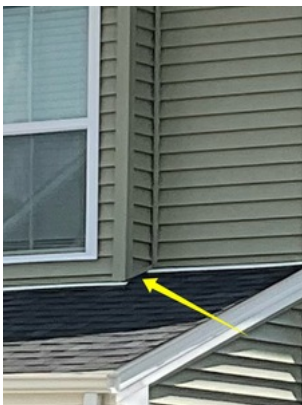
Comment 10

Area where dormer wall meets rooftop shingles needs flashing to divert water from pooling under vinyl siding edge (which should terminate 2 inches above adjoining roof. Where there is no flashing, shingles and sheathing can allow moisture intrusion over time. Recommend repair on left and right sides of dormer by a licensed roofing contractor.

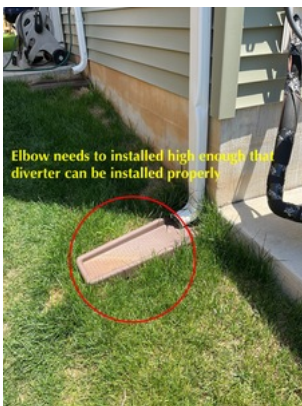
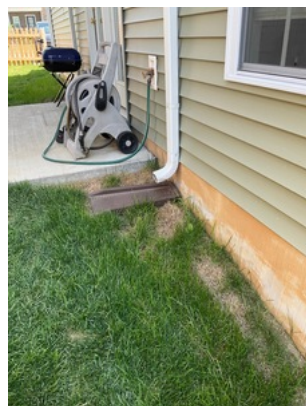
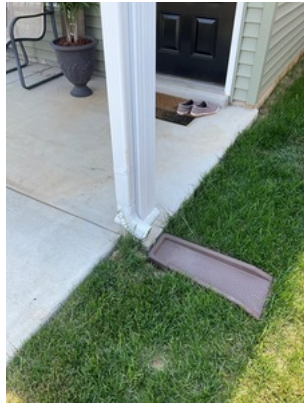
Comment 11

Add gutter extensions to all gutter downspouts to direct water away from home foundation to prevent weakening of the foundation.

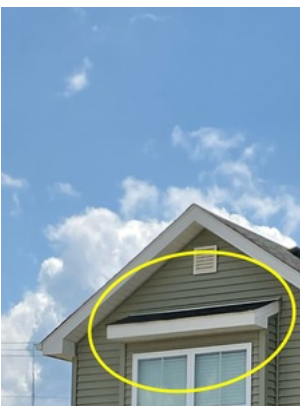
Comment 12

Add section of gutter with downspouts directed off the roof at this roof edge to prevent damage of shingles on roof top below this section

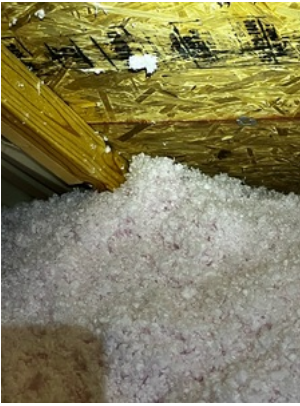
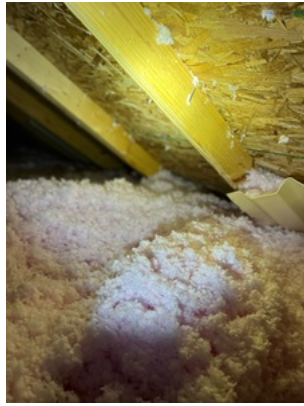
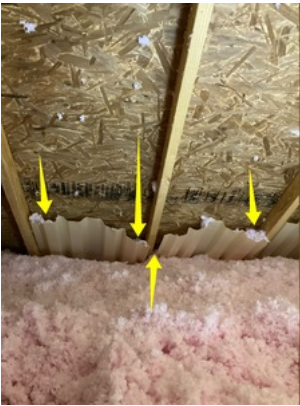
Comment 13

Blown-In insulation covers Soffit vents and guards in some areas. Recommend clearing insulation from the vents/guards. At the time of inspection there were not any moisture issues noted, which can occur with blocked soffit vents. Opening soffit vents can result in a cooler roof surface and longer shingle life, even if there are no moisture problems present. Higher than expected attic temperature was noted at time of inspection.

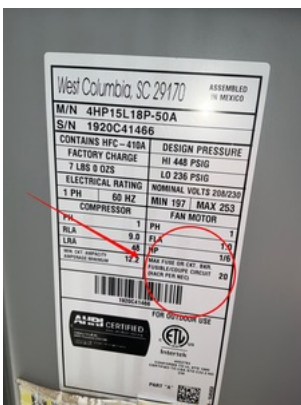
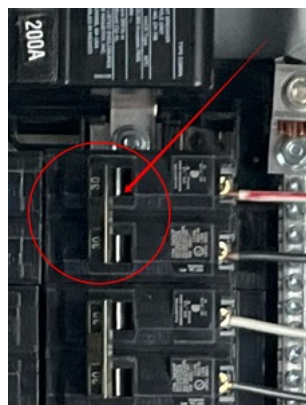
Comment 14

Air Conditioner data tag depicts max breaker size as 20A, Electrical panel has 30A breakers installed for Air Conditioner. Recommend evaluation and repair by licensed Electrician.

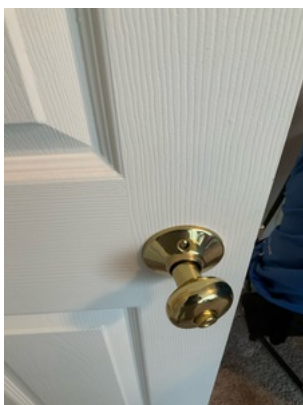
Comment 20

Door knob is broken and should be replaced
