Home Inspection Report

Inspected By: United Home Inspection Group LLC

Inspected On Sun, Jun 5, 2022 at 1:00 PM

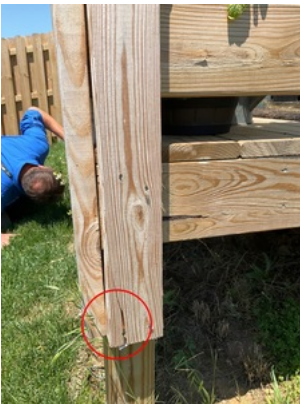
Site: Patios/Decks

Back porch Rim Joist not supported by 4 x 4 posts, being held up by hand rail posts. Showing signs of wood splitting at pressure points. Recommend repair by qualified professional.

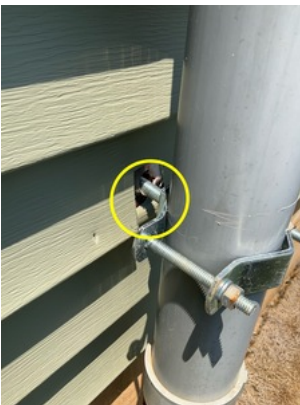
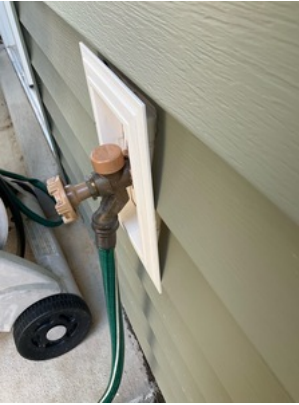
Exterior: Exterior Covering

Area where Conduit is attached to home has not been sealed. Recommend sealing holes/gaps in vinyl to prevent moisture intrusion.

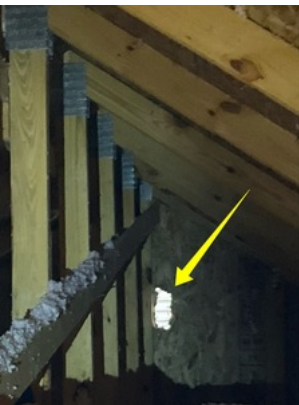
Roofing: Ventilation Present

Gable end vent on front of home is blocked by sheathing on the attic side. Recommend qualified professional to open gable end vent to provide better attic ventilation.

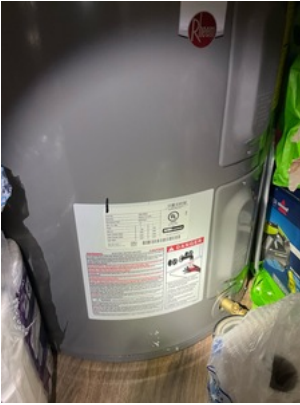
Water Heater

Water heater missing drip pan underneath unit. Location of water heater is such that if it does develop a fast leak, homeowner could become scalded. Recommend installation of water heater drip pan by qualified contractor to prevent water damage from possible future leaking water heater.

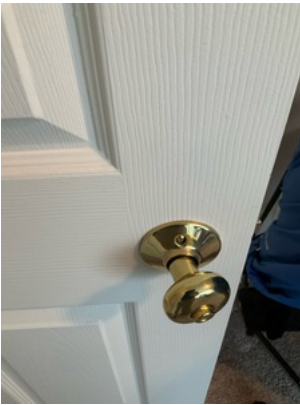
Bedroom #1

Door knob is broken and should be replaced

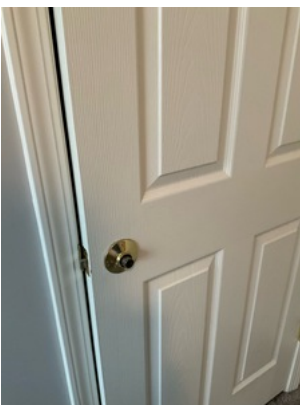
Laundry

Doorknob to laundry closet has broken and fallen off. Replace doorknob.

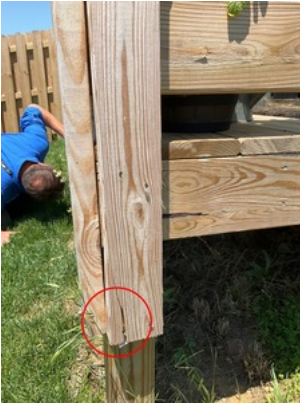
Back porch Rim Joist not supported by 4 x 4 posts, being held up by hand rail posts. Showing signs of wood splitting at pressure points. Recommend repair by qualified professional.

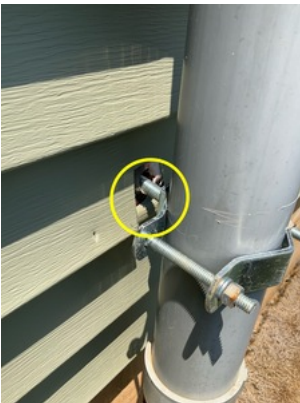
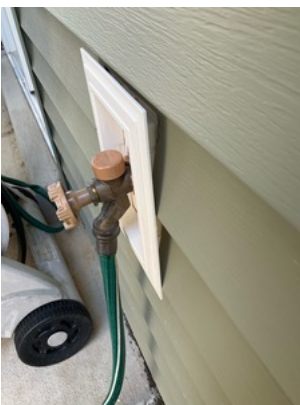
Comment 5

Area where Conduit is attached to home has not been sealed. Recommend sealing holes/gaps in vinyl to prevent moisture intrusion.

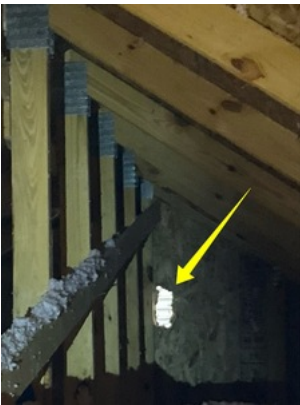
Comment 8

Gable end vent on front of home is blocked by sheathing on the attic side. Recommend qualified professional to open gable end vent to provide better attic ventilation.

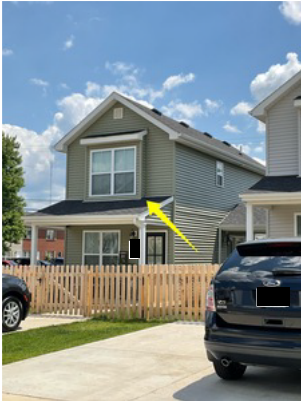
Comment 10

Area where dormer wall meets rooftop shingles needs flashing to divert water from pooling under vinyl siding edge (which should terminate 2 inches above adjoining roof. Where there is no flashing, shingles and sheathing can allow moisture intrusion over time. Recommend repair on left and right sides of dormer by a licensed roofing contractor.

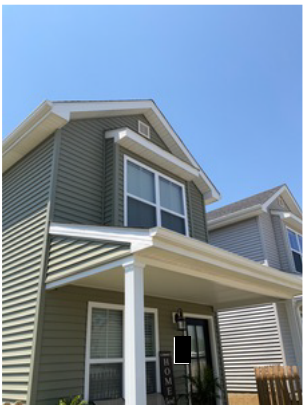
Comment 11

Condition: Repair or Replace

Add gutter extensions to all gutter downspouts to direct water away from home foundation to prevent weakening of the foundation.

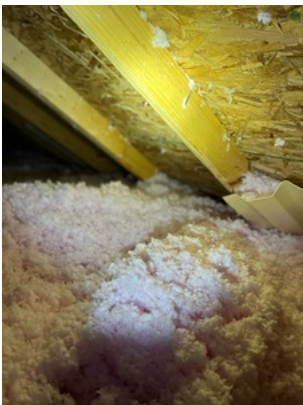
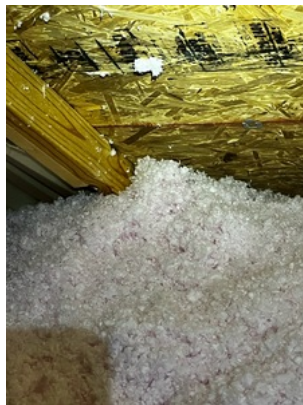
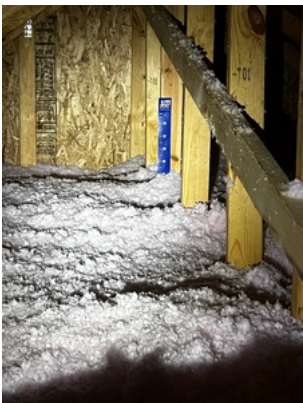
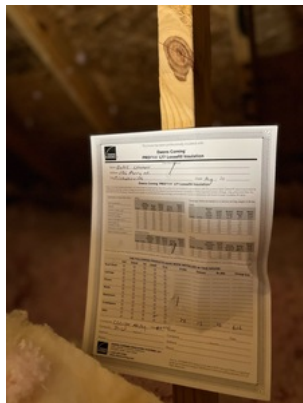
Comment 13

Condition: Repair or Replace

Blown-In insulation covers Soffit vents and guards in some areas. Recommend clearing insulation from the vents/guards. At the time of inspection there were not any moisture issues noted, which can occur with blocked soffit vents. Opening soffit vents can result in a cooler roof surface and longer shingle life, even if there are no moisture problems present. Higher than expected attic temperature was noted at time of inspection.

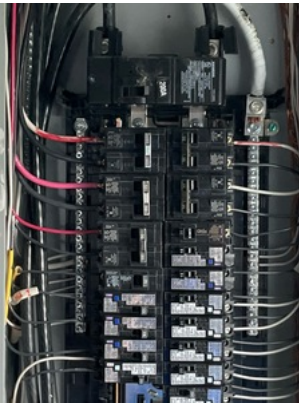
Condition: Repair or Replace

Air Conditioner data tag depicts max breaker size as 20A, Electrical panel has 30A breakers installed for Air Conditioner. Recommend evaluation and repair by licensed Electrician.

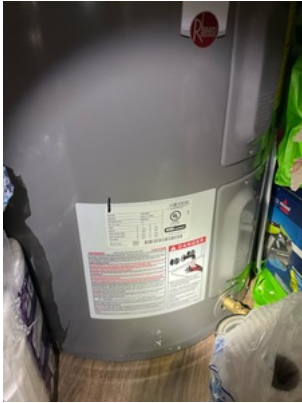
Water heater missing drip pan underneath unit. Location of water heater is such that if it does develop a fast leak, homeowner could become scalded. Recommend installation of water heater drip pan by qualified contractor to prevent water damage from possible future leaking water heater.

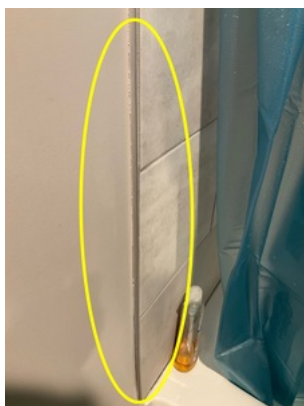
Tile

Condition: Marginal

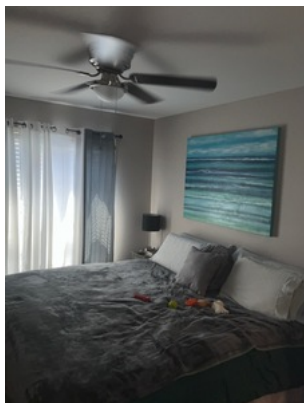
Bedroom #1

Door knob is broken and should be replaced

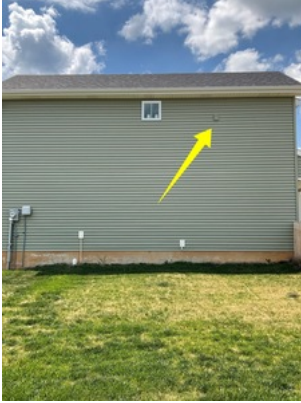
Dryer Venting

Dryer venting Not Inspected due to obstruction on inside and located on second floor exterior.

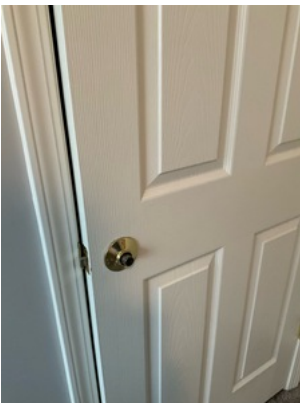
Doorknob to laundry closet has broken and fallen off. Replace doorknob.
